## BOLTED TANKS SPEED KUGLUKTUK'S WATER TREATMENT PLANT UPGRADE

The water treatment plant upgrade for the hamlet of Kugluktuk is one of the few modern Nunavut plants built by shipping construction materials to the remote Arctic location rather than as a factory built modular plant.

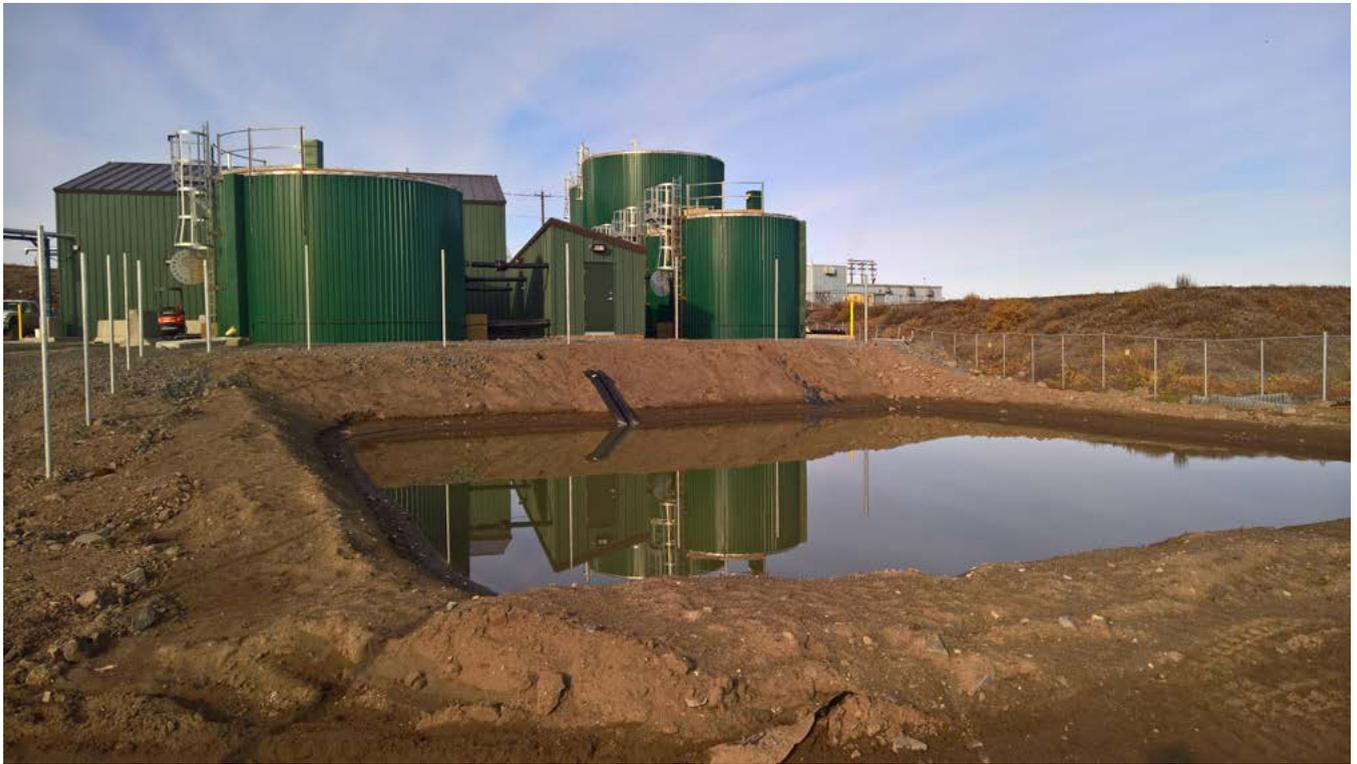
The slow sand filters discharge pond.

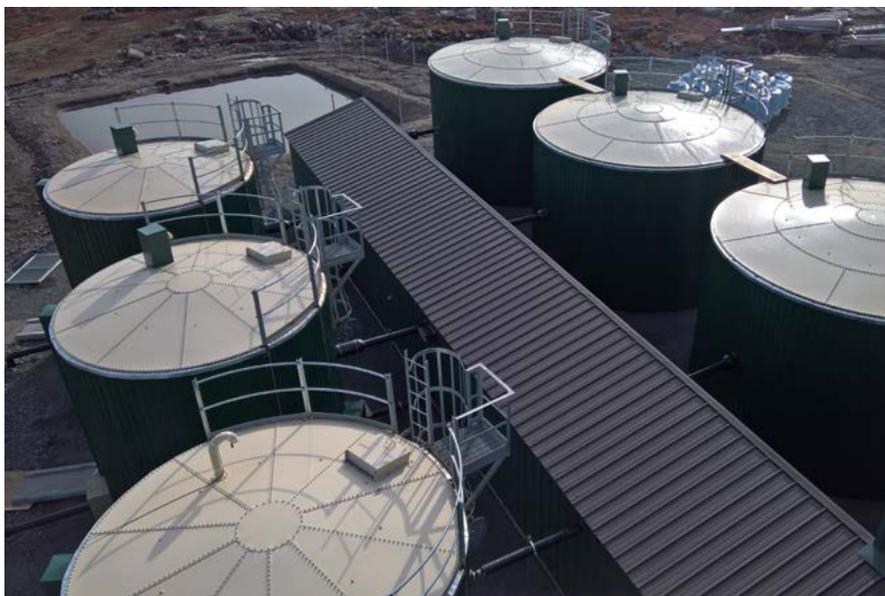
Roughing filters on the left and slow sand filters on the right.

Because the Williams Engineering design specified slow sand filtration, it required eight large exterior tanks, ranging in size from 74 m<sup>3</sup> – 560 m<sup>3</sup>. Delivering the treated water, filter feed, three roughing and three slow sand tanks to the shore of the Arctic Ocean beside the Coppermine River was challenging.

Most tanks are concrete or field welded steel, but Kugluktuk's were built on site with factory fabricated and coated panels that are bolted into place. Bolted tanks have the strength of steel and require less site work than concrete tanks. Below ground concrete tanks would also not be compatible with the geological and permafrost conditions.
